Inspection/meeting notes and pictures of Weyerhaeuser – Longview BART emission units.

Meeting occurred on Feb. 13, 2008 to go over comments on the BART report. The company will respond to the comments and follow-up a short time later with a revised BART report. Main plant contact was Greg Bean and the consultant was Jay Willenberg of CH2M-Hill. Marc Crooks requested to accompany me to this meeting/inspection. This was my first visit to this plant site.

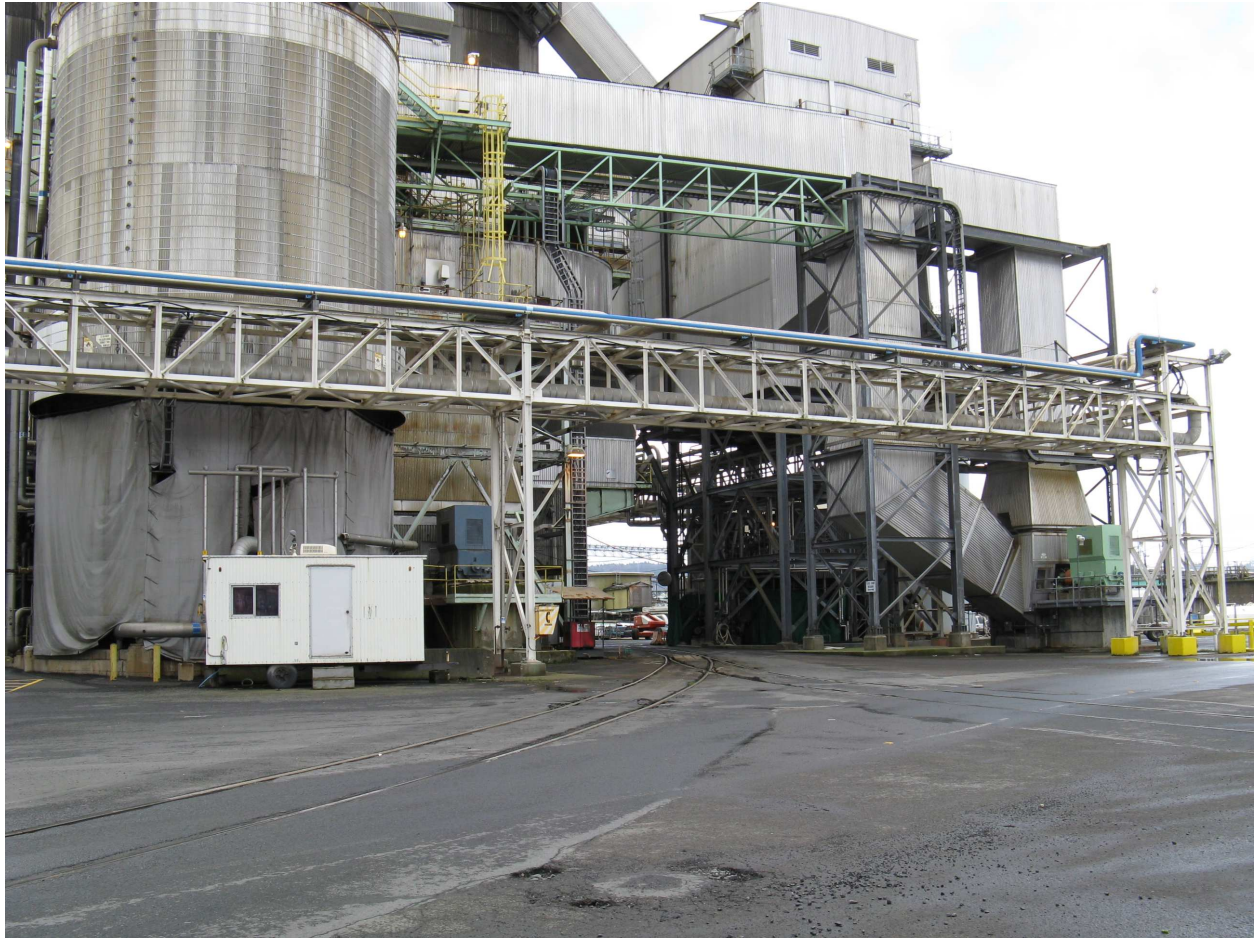
Recovery boiler ESPs at ground level. 3 separate ESPs running in parallel. 2 on then left and 1 on the right.

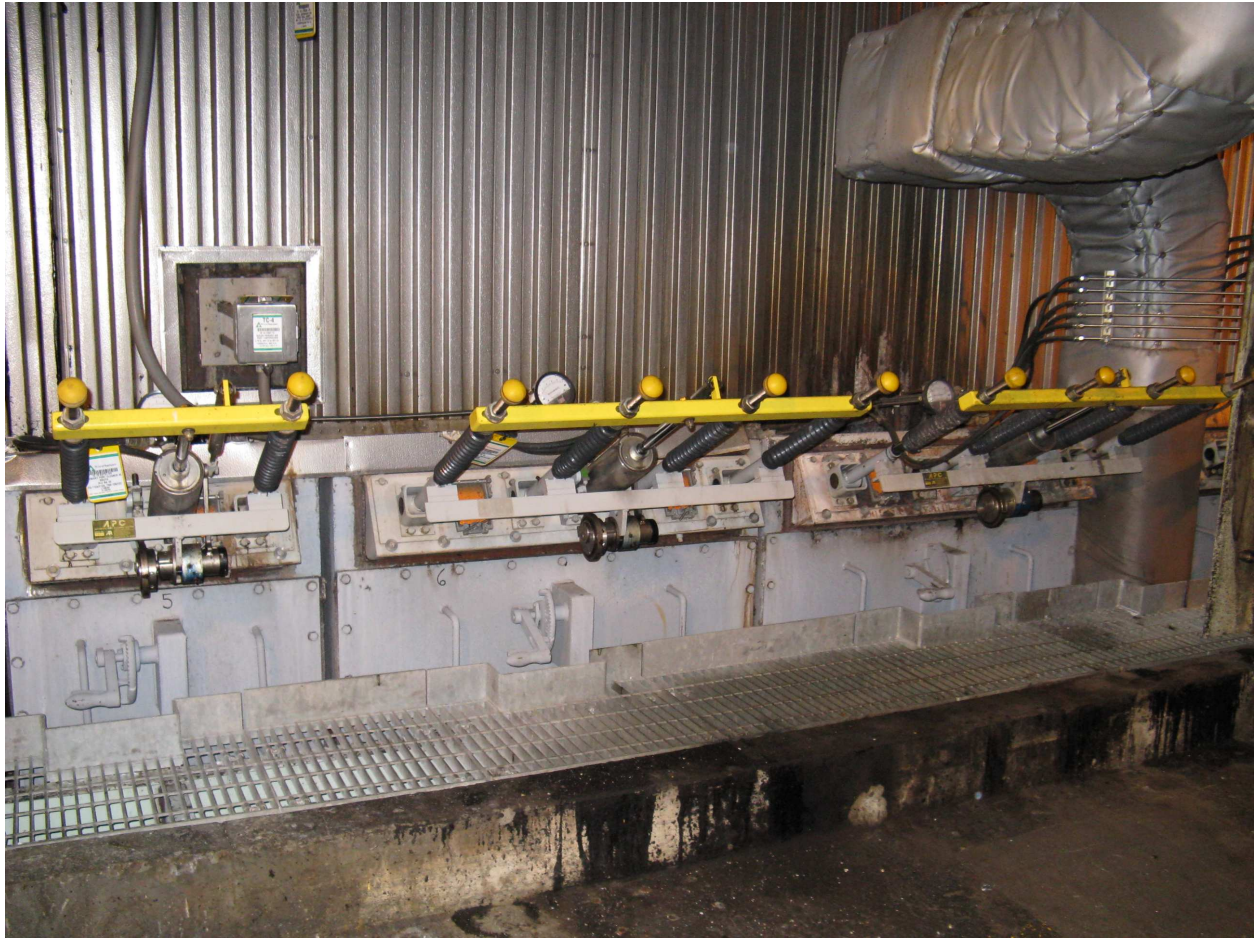
Recovery boiler primary air inlets. They surround the entire furnace at this level. The devices with a yellow ball on the end are pneumatic plungers used to keep the air ports open. The primary air enters via the silver square duct below the plungers.

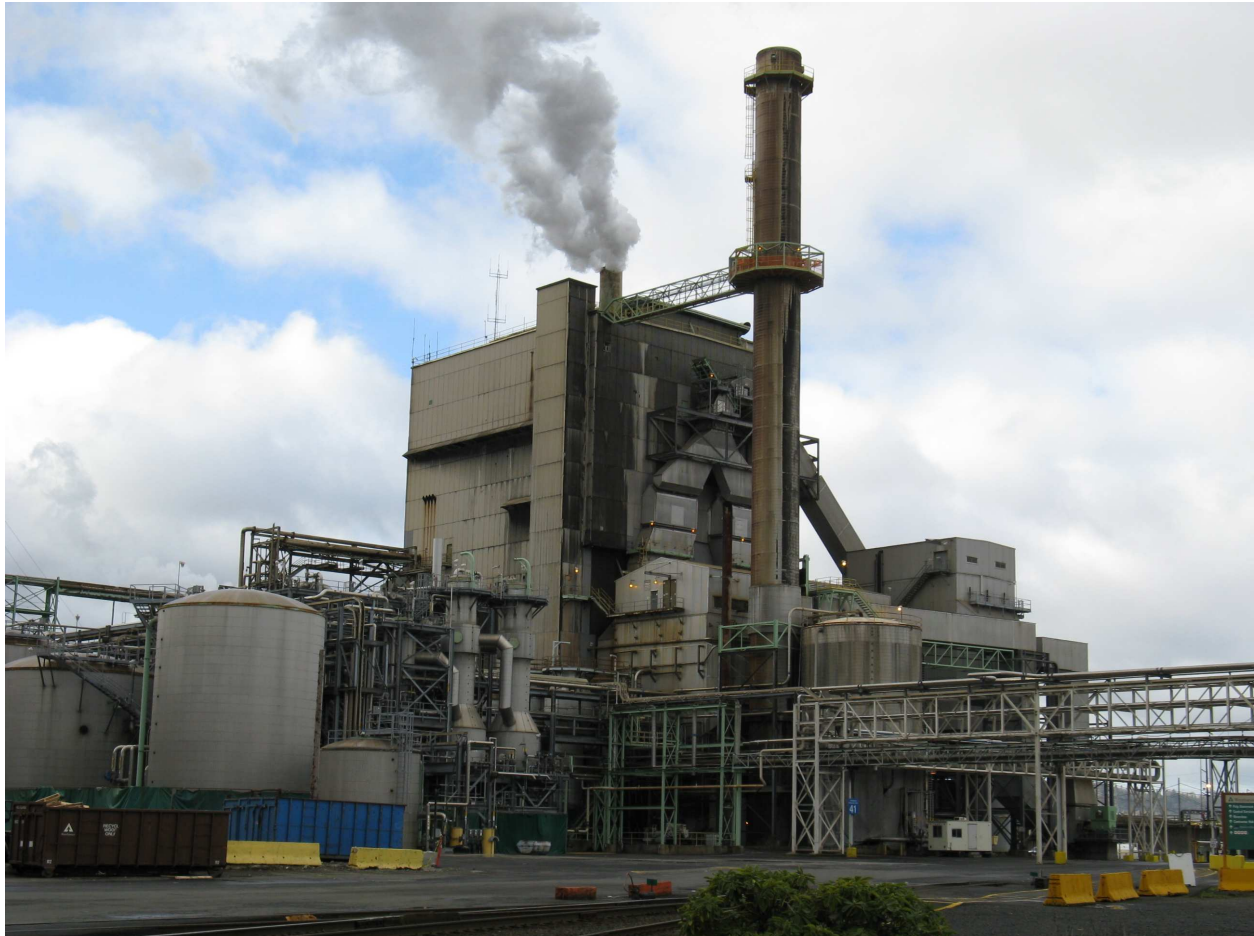
Recovery boiler building and stack. The ESP inlets are the upside down 'y' and the third rectangular duct rising up from the right. They are then ducted together on the near face of the ESPs to enter the stack. The NCG incinerator scrubber stack enters the recovery boiler flue after the ESPs and before the CEMs. the CEMs are located at the level of the catwalk even with the green support truss for the stack. The support truss and CEM/stack sampling platform are not at the same elevation.

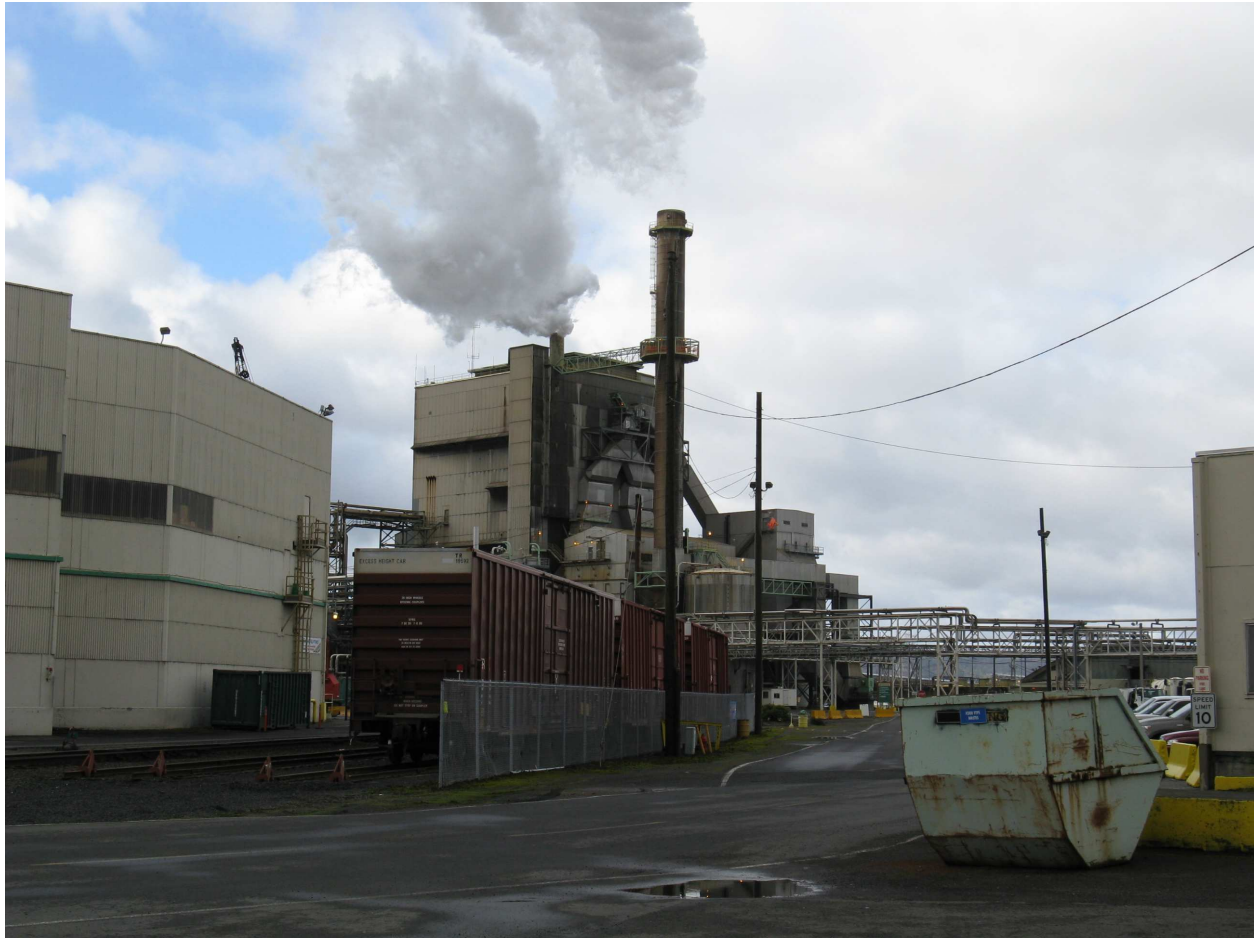
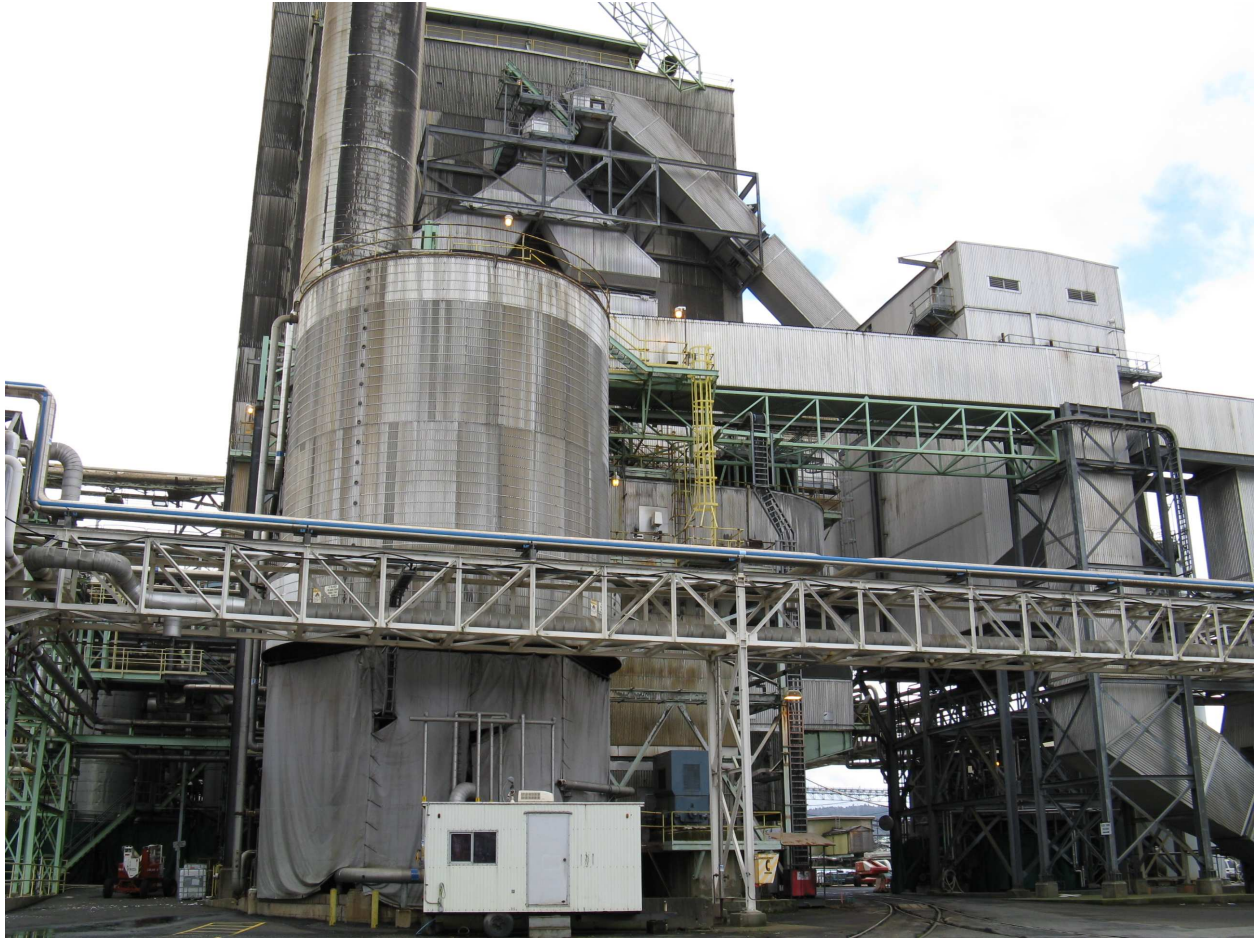
A closer picture of how the ESPS are ducted to the stack and recovery boiler.

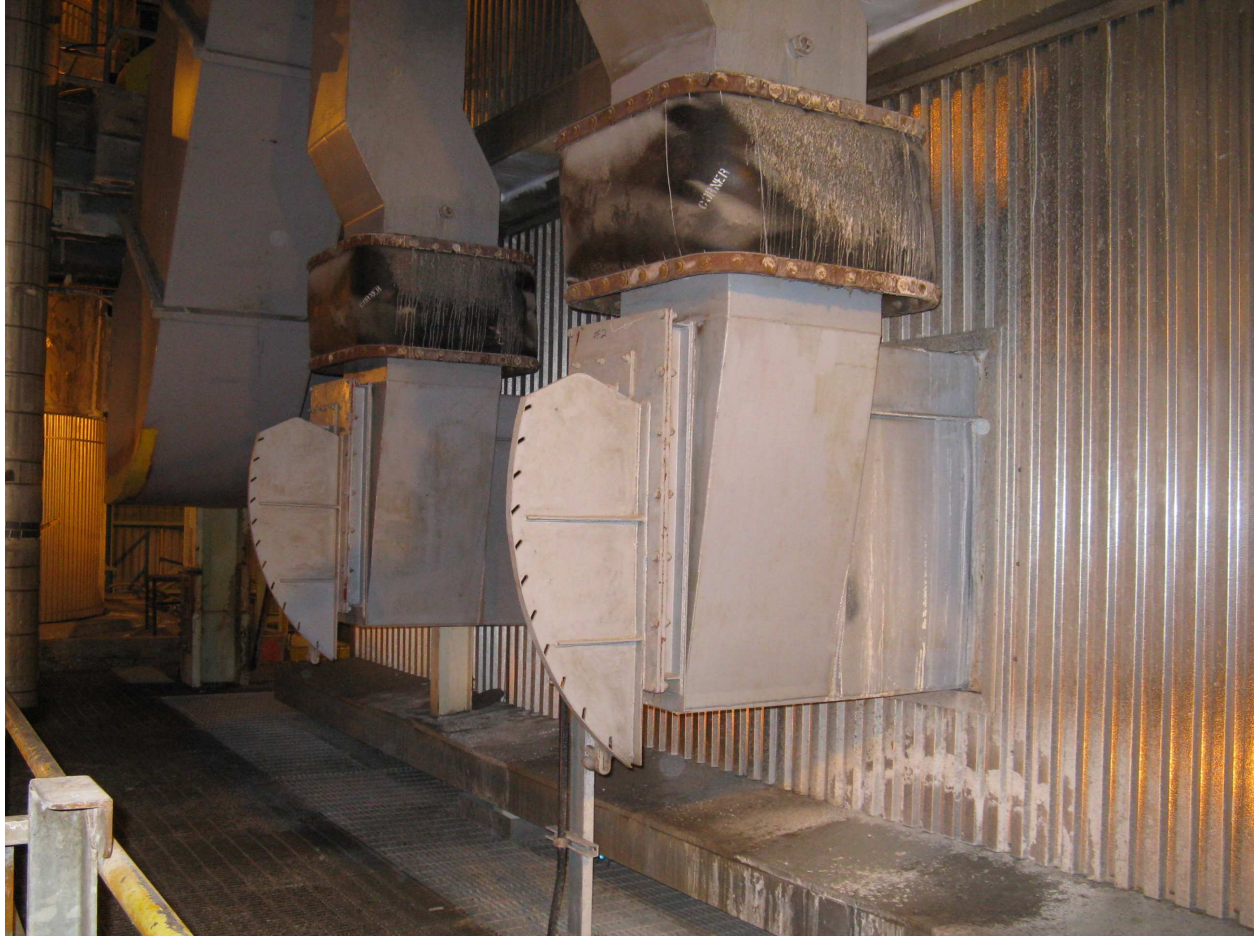
Recovery furnace tertiary air ports.

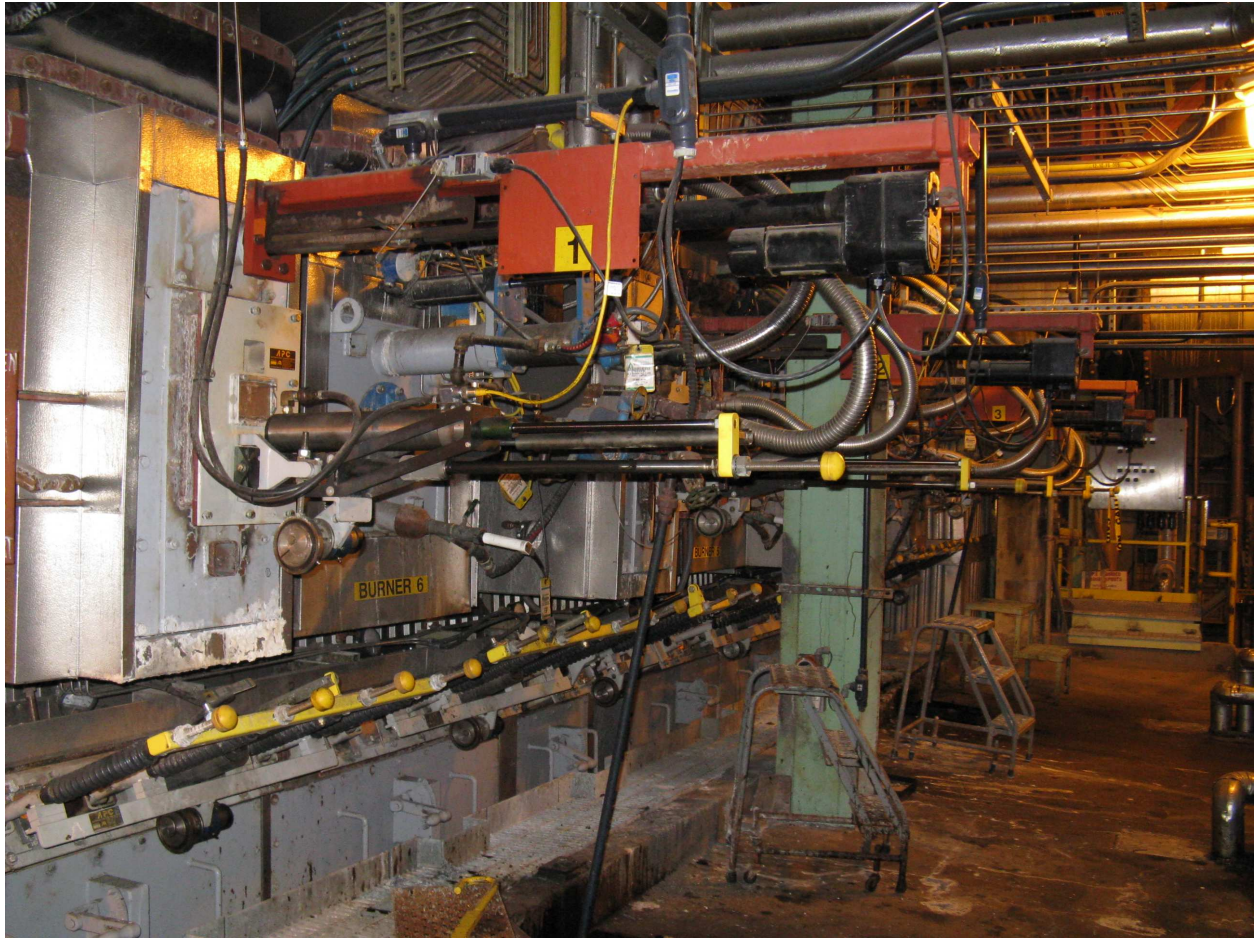
Recovery boiler secondary air ports and the residual oil burners. The Secondary air inlets are with numbered plates, the oil injectors are located between the air inlets. The rods with the yellow ball on the end are pneumatic plungers to keep the air ports clear.

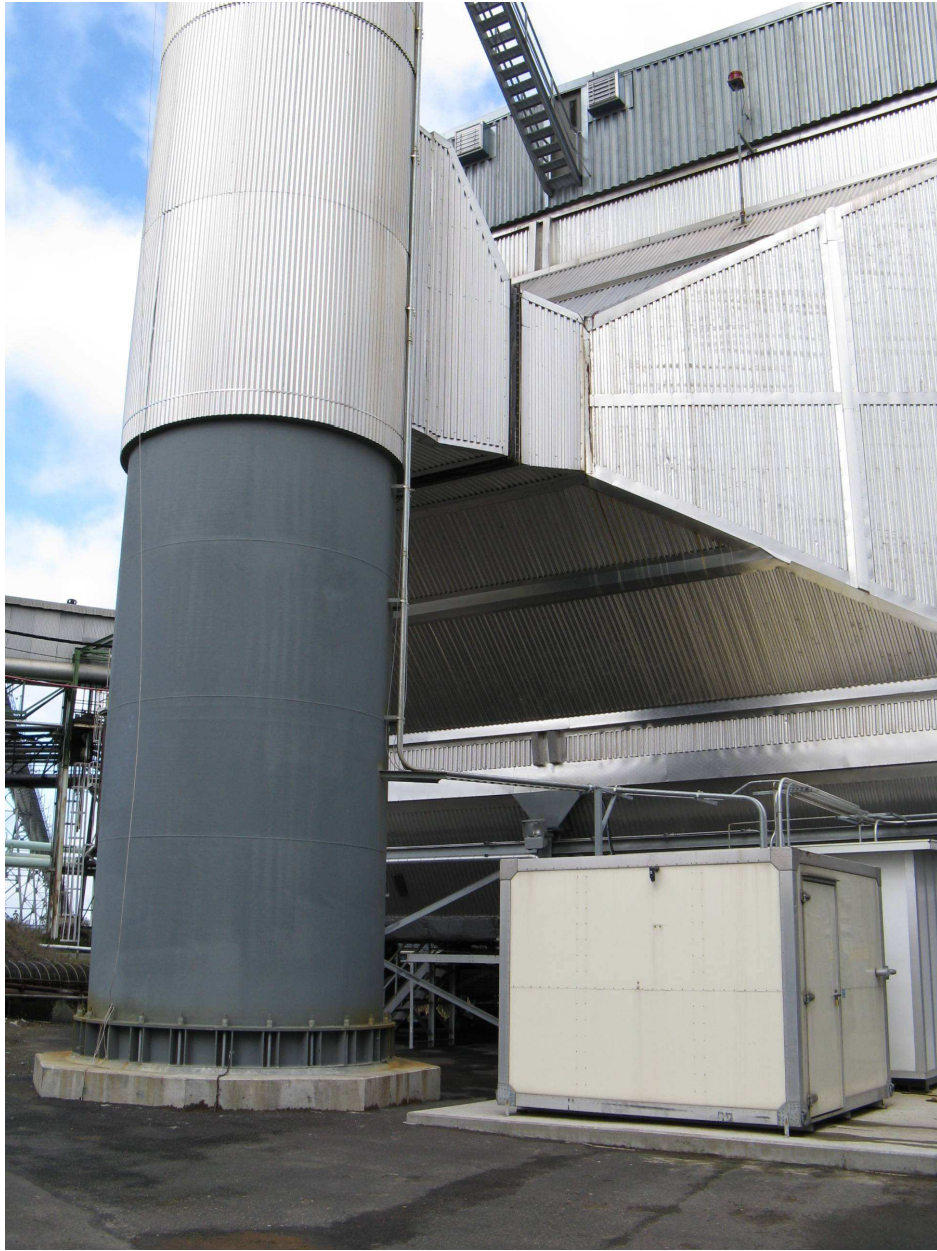
Base of Power boiler stack and its ESP. the CEM and stack sampling ports are accessed via stairway from the top of the ESP rather than a stack mounted ladder as at the Recovery boiler.

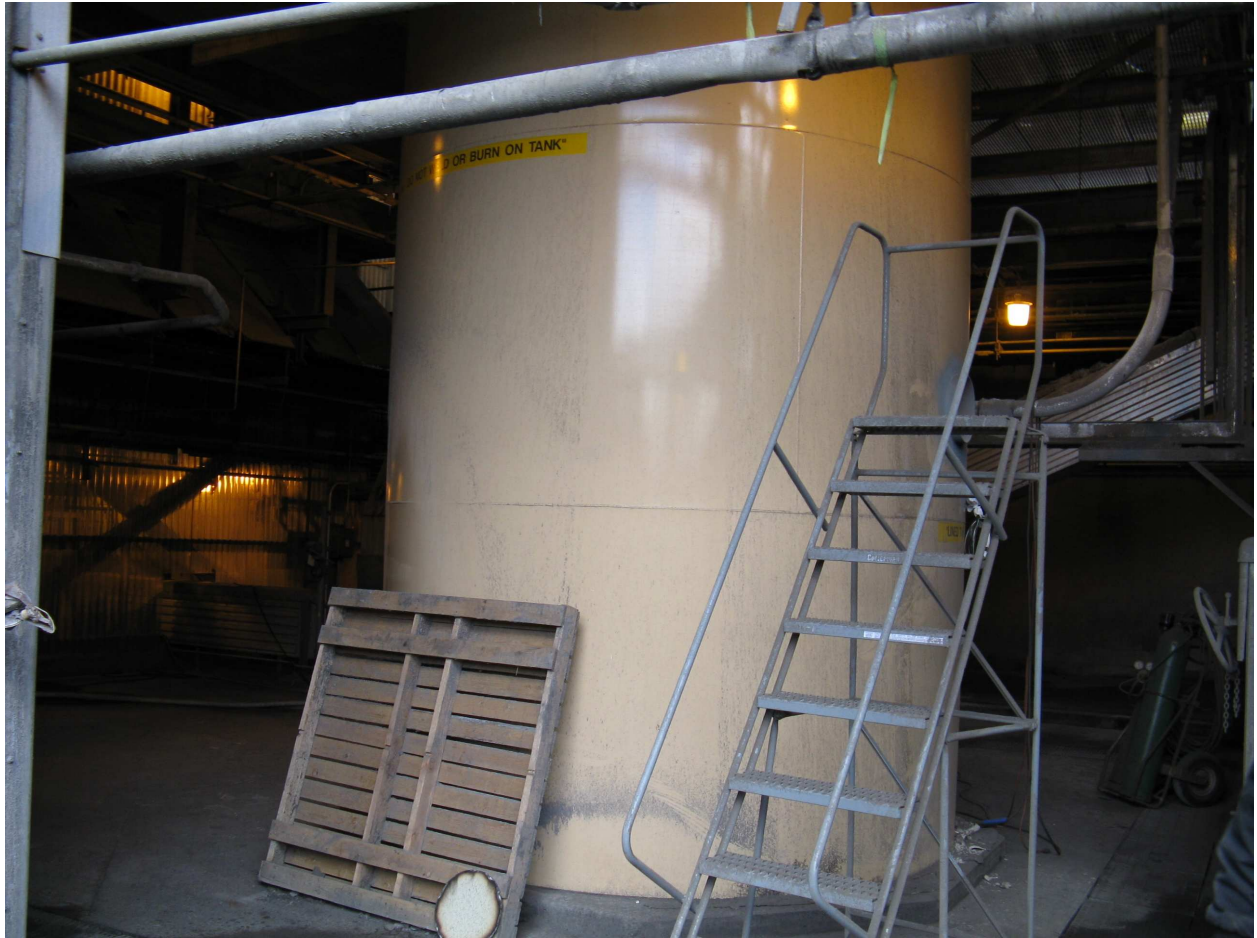
Trona storage from West side of building

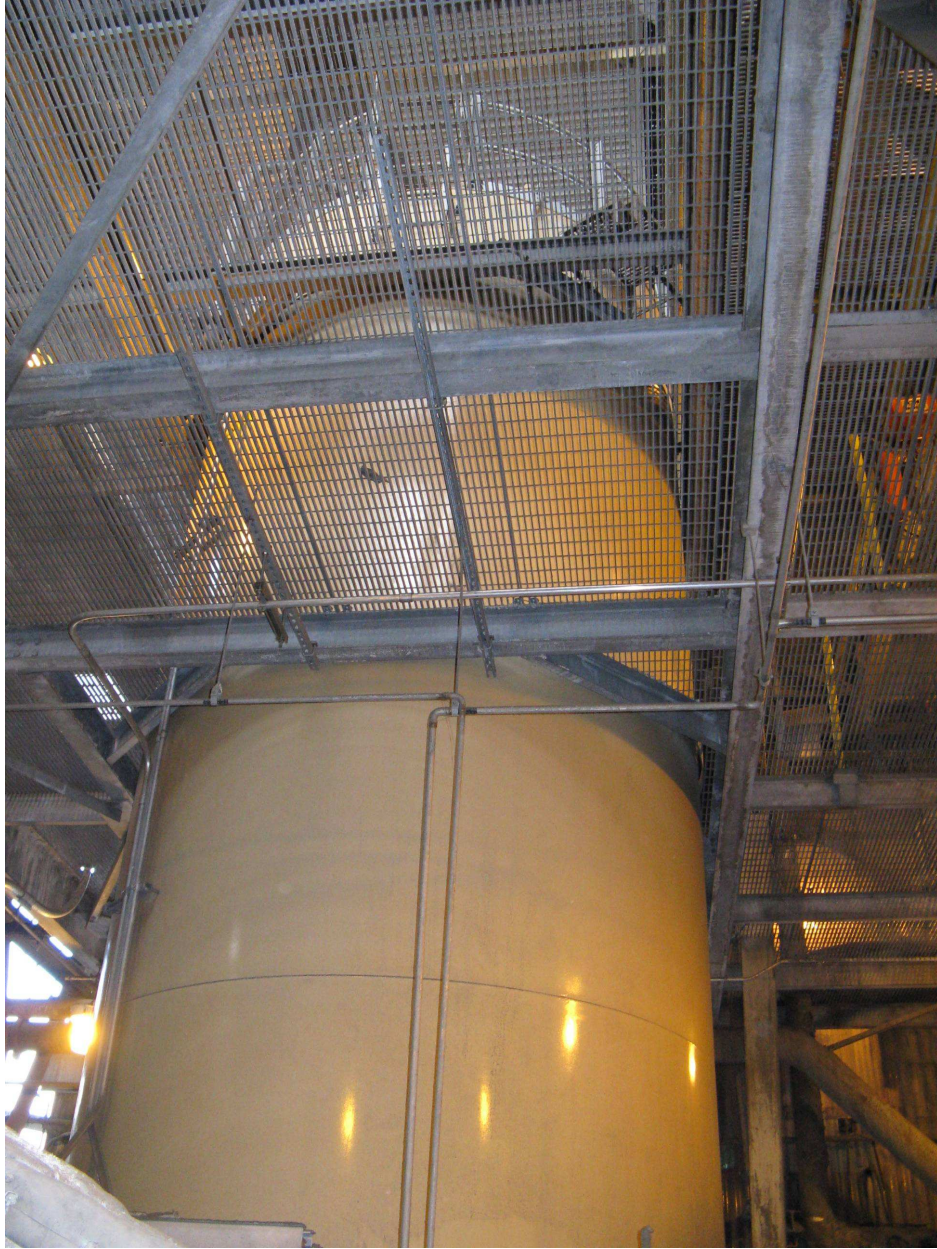
Trona storage looking up from ground level. The flue and injection point is on the left.

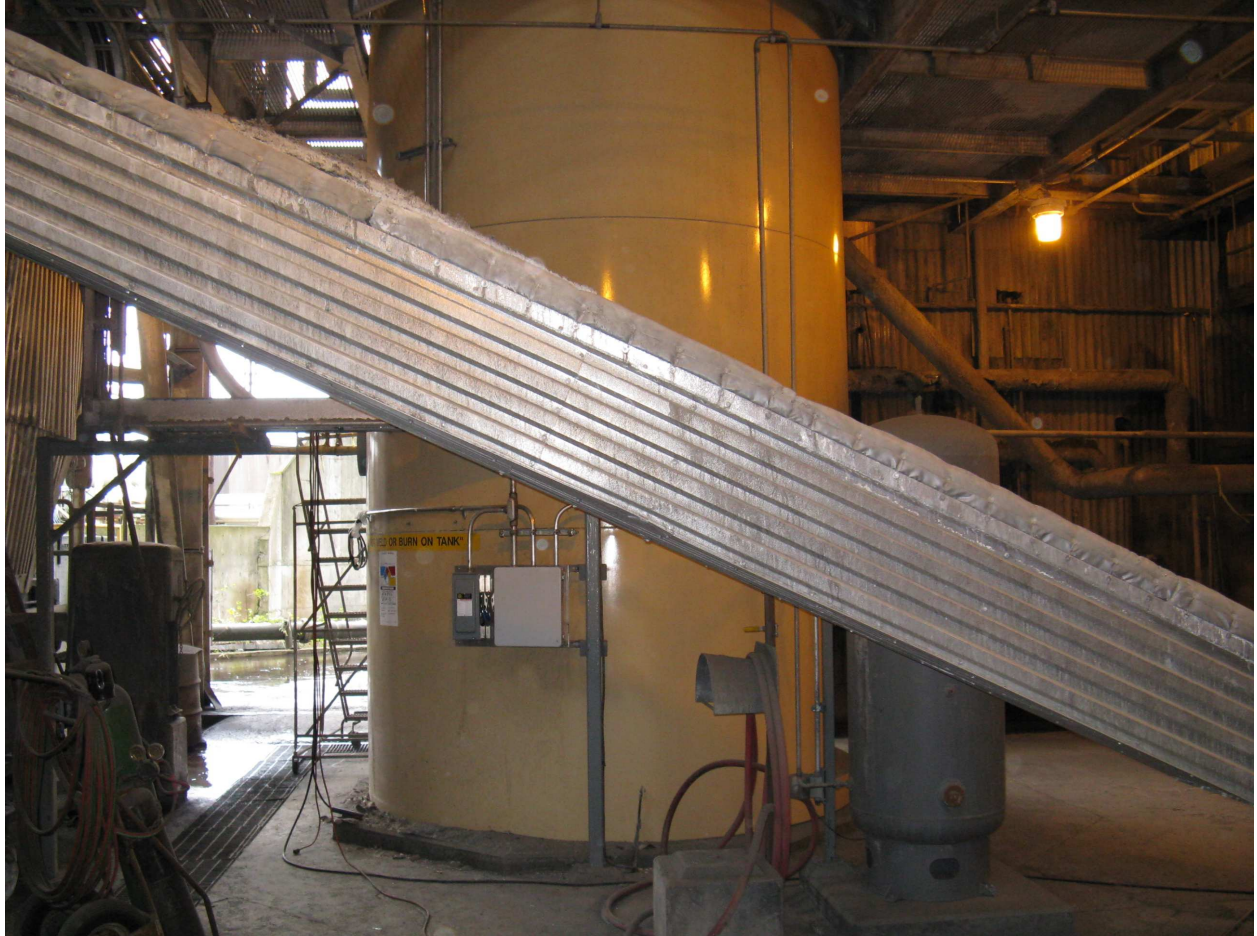
Trona storage with a covered screw conveyor in front. Picture from the west side is taken from the opening beyond the portable stairway. Abandoned structures from earlier pulp mills is visible in the background.
